Town of Winchester

Aquatic Plant Point Intercept Report: Rainbow and Tamarack Lake

July and August 2024

Prepared By: North Lakeland Discovery Center

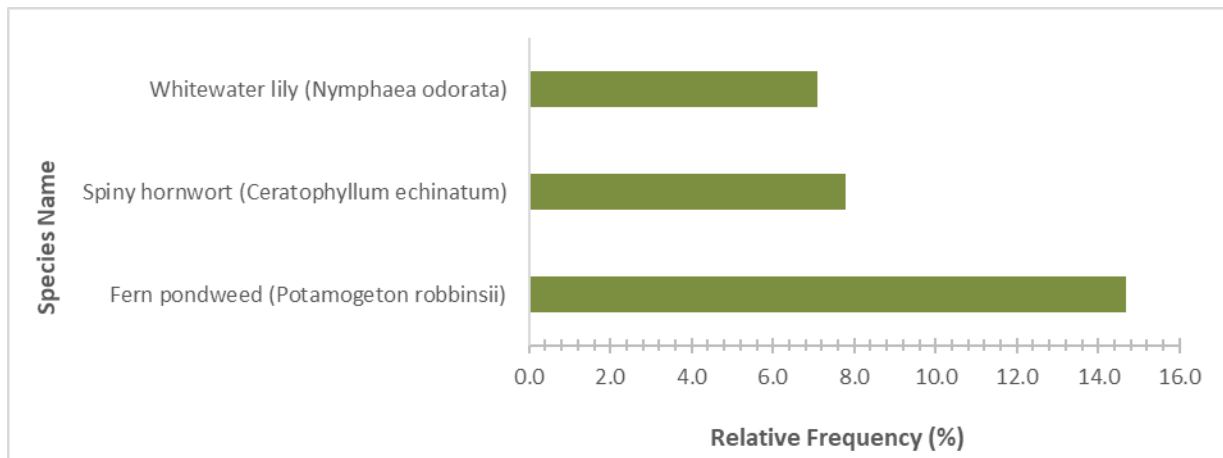
Figure 1: Rainbow Lake 2024 relative frequency (%) of occurrence of aquatic plant species collected in rake during the 2024 point-intercept survey.

A total of 359 points were sampled on Rainbow, with vegetation present at 201 of those sites. Plants were found at depths up to 15 feet, while the overall maximum depth recorded was 37 feet. The frequency of occurrence of plants at sites shallower than maximum depth of plants was 84.45% of sites, with an average of 2.58 species per site. Across all vegetated sites, the average number of species was 3.07 per site. The average rake fullness rating was 2.38, indicating moderate plant density, with distribution shown in Map 1. In total, 32 plant species were collected using the rake method, and 39 species were documented when including visual sightings. The high Simpson Diversity Index of 0.94 reflects a well-balanced and diverse aquatic plant community in Rainbow.

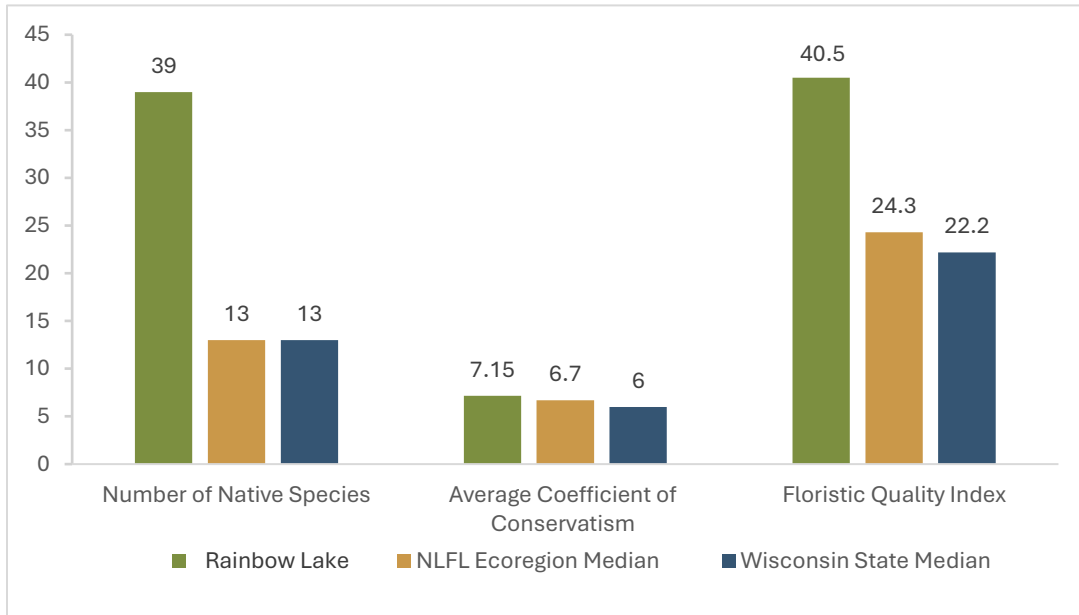
Figure 2: Floristic Quality Assessment of Rainbow Lake using data from 2024-point intercept survey. Analysis follows Nichols (1999).

Analysis of the data collected from the plant point-intercept survey conducted on Rainbow Lake indicates that it contains a relatively healthy plant community, and no aquatic invasive species were detected. Rainbow Lake's floristic quality index value of 40.5 is higher than the state and regional means. Rainbow Lake also has a conservatism value of 7.15 out of 10. These values indicate a high florist integrity and a lower sensitivity to changes in the proportion and distribution of vegetation. Tamarack Lake's floristic quality index value of 35.4 is higher than the state and regional means. Tamarack Lake also has a conservatism value of 7.5 out of 10. These values indicate a higher florist integrity and a lower sensitivity to changes in the proportion and distribution of vegetation. It is important to note that the FQI can be impacted by both the size and the heterogeneity of the lake (Bernthal 2003).

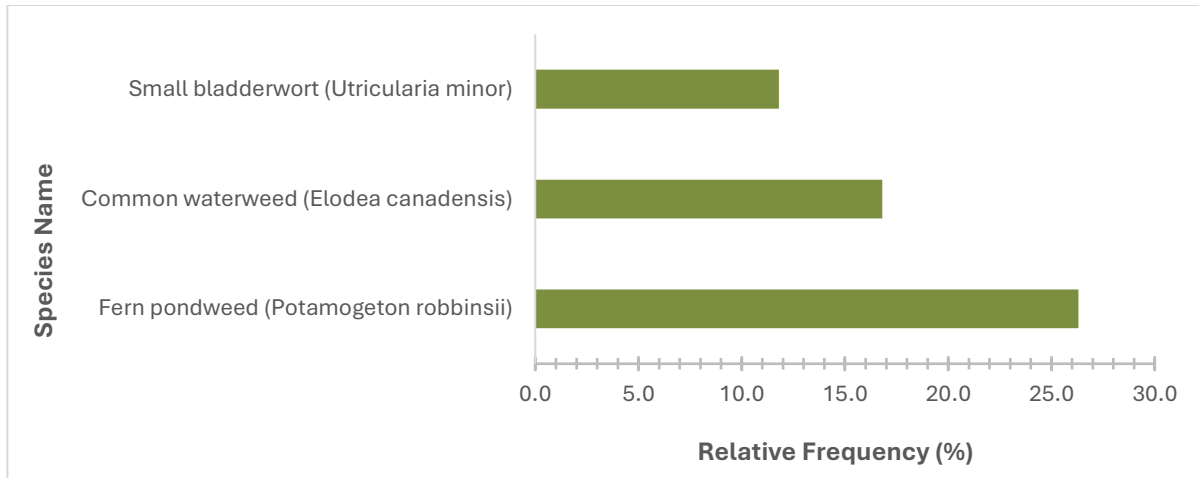
Figure 3: Tamarack Lake 2024 relative frequency (%) of occurrence of aquatic plant species collected in rake during the 2024 point-intercept survey.

A total of 187 points were sampled on Tamarack, with vegetation observed at 152 of those sites. Aquatic plants were found at depths up to 14 feet, while the overall maximum depth recorded was 30 feet. Within the sites shallower than the maximum depth of plants, the frequency of plant occurrence was 91.57%, though the average number of species per site in this zone was 0.19. Across all vegetated sites, the average species count was 2.40. The average rake fullness rating was 2.77, suggesting relatively dense vegetation, with its spatial distribution illustrated in Map 5. A total of 25 species were collected using the rake method, with 30 species documented overall when including visual sightings. The Simpson Diversity Index for Tamarack was 0.87, indicating slightly above average species diversity within the aquatic plant community.

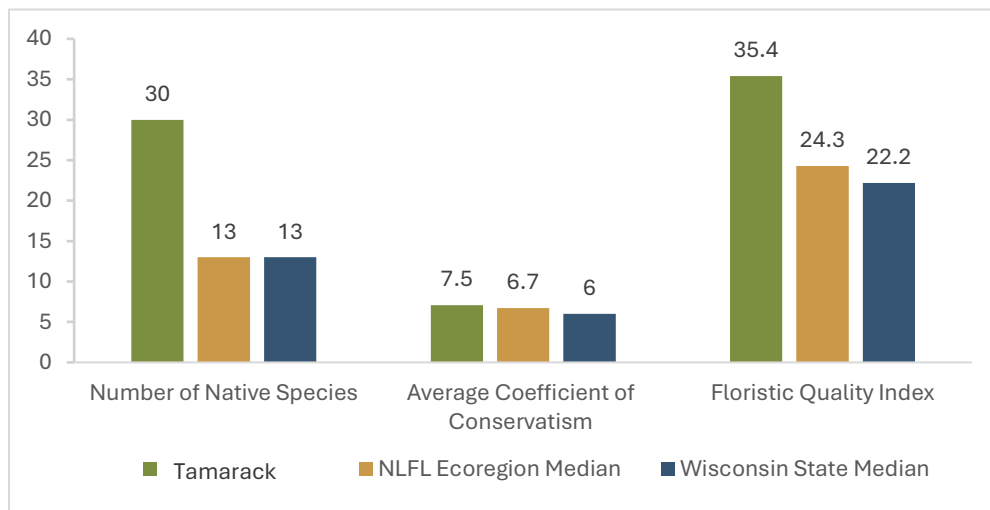
Figure 4: Floristic Quality Assessment of Tamarack Lake using data from 2024-point intercept survey. Analysis follows Nichols (1999).
